Geo-Mechanical Behavior of Toe Excavated Land Slope

Abstract

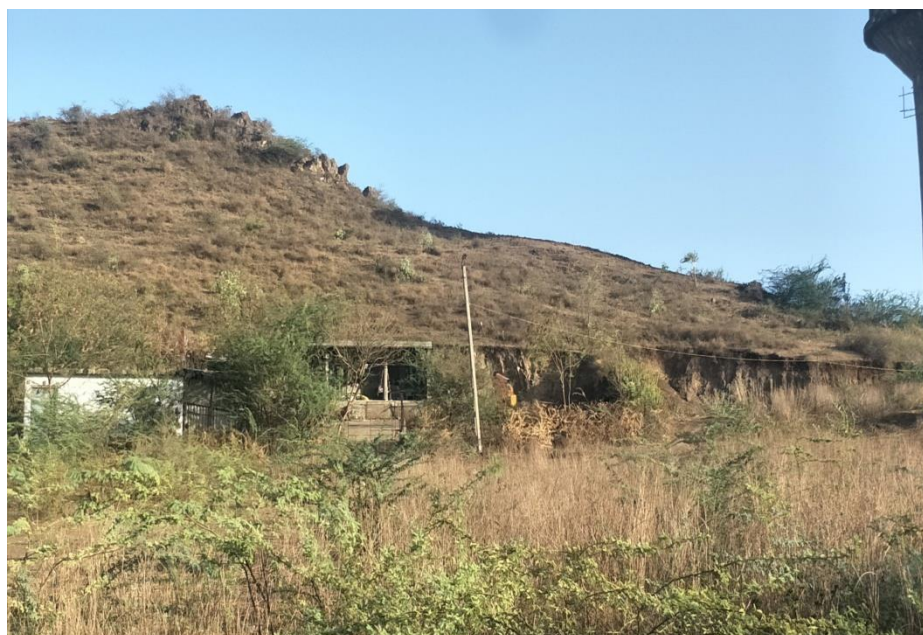
Fig-1. Toe excavation of hill slope at Barman Mota Village of Gujarat

Besides the vulnerability of landslides due to toe cutting, competent authorities should impose strict restrictions. However, we still see a lack of action on such an illegal excavation of the toe of the hill slope. In our previous visit in April 2022, at Barman-mota village of Amreli district of Gujarat, India, we observed such activities on the downhill slope, presented here in Fig-1, for reader's reference. People of the village have excavated the toe

of the hill and built the residence in that place which is dangerous as it might trigger a landslide during the rainy season. Also, besides that, they started farming in the excavated area of the toe.

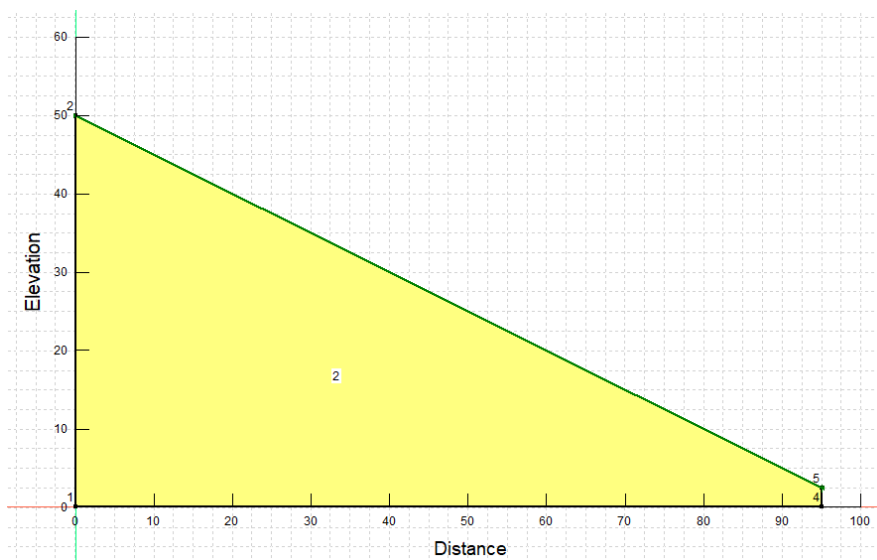
Fig-1 Geometry of the slope model for 25° slope angle with 5 m toe excavation

The present study investigates the effect of the toe excavation on the hill slope stability. The geometry of the slope was used to vary in terms of the inclination of the slope angle in the range of the 25° to 45°; this range was investigated in three parts, i.e., i) with 25° inclination, ii) with 35° inclination, iii) with 45° inclination of the slope. Further, each inclination was analyzed for different shear parameters, i.e., cohesion and angle of internal friction. Cohesion was used to vary in the range of 10 KPa to 70 KPa in increment of 20 KPa, while on another hand angle of internal friction was used to vary in the range of 10° to 35° with an increment of 5°. The geometry of the slope used in the investigation is, as presented in fig-1. The height of the slope is 50 m. The stability of the slope was analyzed in a dry state of the slope. A groundwater table was encountered at the base for dry slope conditions. The Morgenstern-price method is employed to analyze the slope stability as this method can simulate the effect of both vertical and horizontal interaction force between the slice. The surface soil's behavior was modeled as linear and elastic-plastic soil material using the Mohr-coulomb material model.

Toe excavations were simulated on the slope in 5 m horizontal excavation intervals until the slope got fails. The strength parameters called cohesion and angle of internal friction was varied to analyze the effect of these shear strength parameters on the toe excavation.

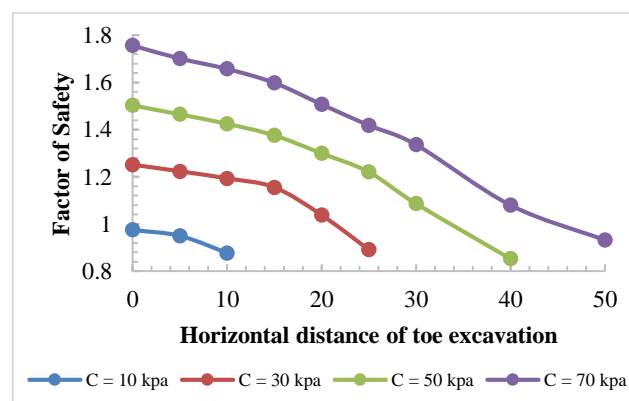
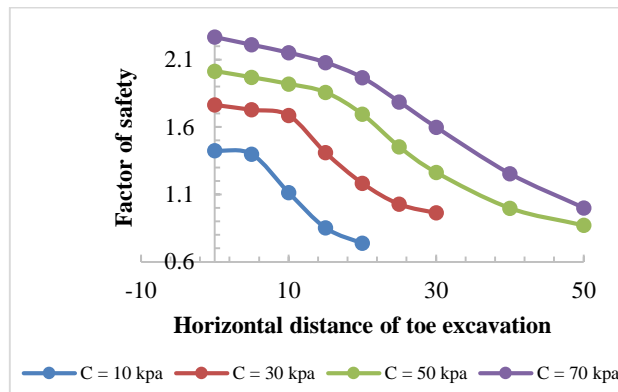
Fig-2, Effect of toe excavation on hill slope stability for 25° slope angle, a) $\phi = 20^\circ$, b) $\phi = 25^\circ$, c) $\phi = 30^\circ$, d) $\phi = 35^\circ$

Results of the investigation for all three cases are presented here in fig-2, fig-3, and fig-4 in the graphical demonstration.

Extensive stability analysis of hillslope with toe excavation reveals how the stability of the slope gets affected as the toe is excavated horizontally. From the study, it's observed that toe excavation can sustain stability in a dry state maximum of up to 50 m for 25° slope angle, up to 40 m for 35° slope angle, and up to 30 m for 45° slope angle (Fig-1, Fig-2, and Fig-3). Analysis shows that the more flatter slope i.e. 35° and 45° angle slope with lesser cohesion and angle of internal friction falling under self weight (i.e., Fig-2, (a) – $\phi = 20$ and $C = 10$ & , $\phi = 20$ and $C = 30$ (b) $\phi = 20$ and $C = 10$ and Fig-3, (a) - $\phi = 20$ and $C = 10$; $C = 30$, (b) - $\phi = 25$ and $C = 10$; $C = 30$, (c) - $\phi = 30$ and $C = 10$, (d) - $\phi = 35$ and $C = 10$). Which represents the vertical toe excavation for such a slope for any reason it is not possible for such a kind of slope. Besides this, for higher cohesion and angle of internal friction, even for steeper slopes up to 45° of inclination, the safe toe excavation up to 30 m on dry a slope could be possible (Fig-4). A flat slope allows more extent of the toe excavation, which is up to 50 m on a 50 m high slope (Fig-2).

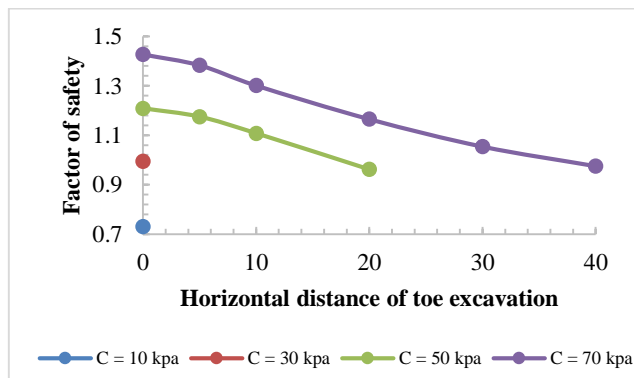
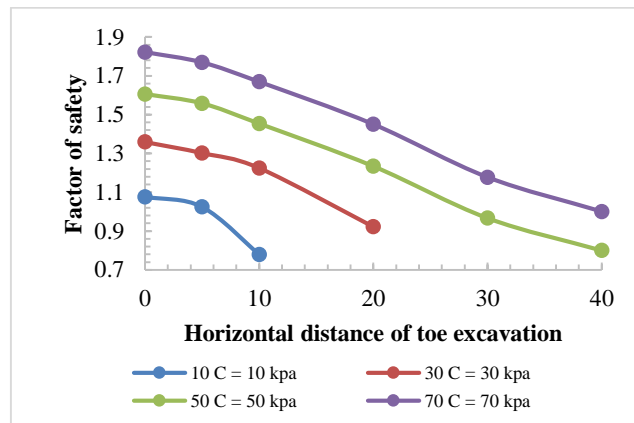
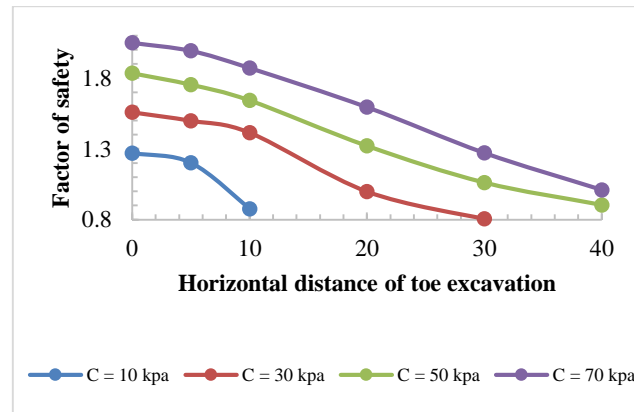
Fig-3, Effect of toe excavation on hill slope stability for 35° slope angle, a) $\phi = 20^\circ$, b) $\phi = 25^\circ$, c) $\phi = 30^\circ$, d) $\phi = 35^\circ$

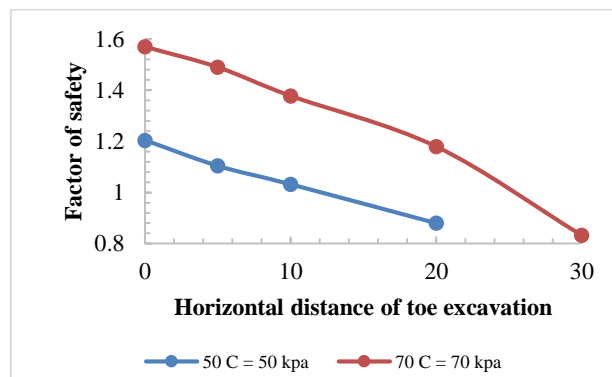
Fig-4, Effect of toe excavation on hill slope stability for 45° slope angle, a) $\phi = 20^\circ$, b) $\phi = 25^\circ$, c) $\phi = 30^\circ$, d) $\phi = 35^\circ$
